05 August 2021

Matt Warren
Paekakariki Surf Life Saving Club
The Parade
Paekakariki

Structural Inspection of Surf Club Building – The Parade, Paekakariki

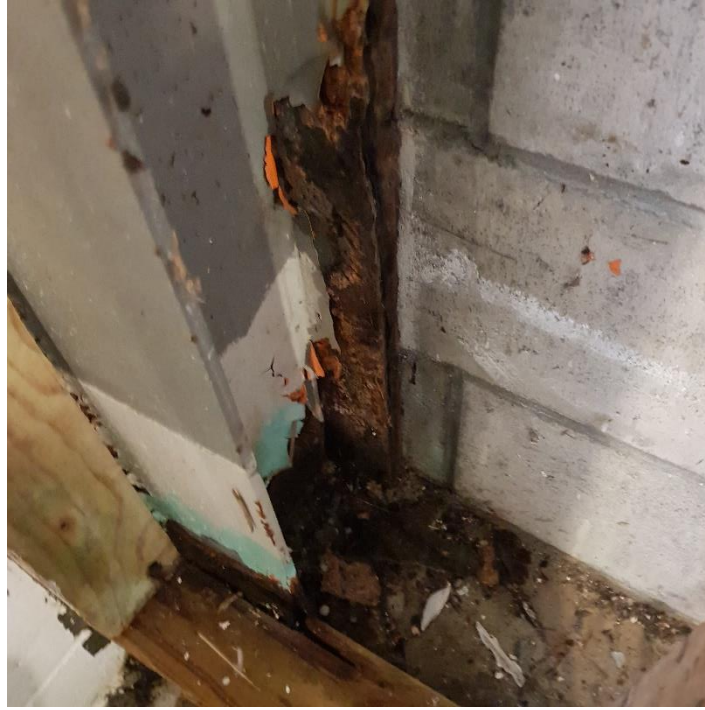
The change rooms consist of primarily steel frames in the east-west direction and concrete masonry block walls on the perimeter. We observed severe corrosion of the steel columns, particularly at the base and flanges. This corrosion is approximated at 50% of the steel section. We also noted some bracing elements on the western face has rusted off the connections to the columns.

Severe corrosion of steel column flanges and base plate

We recommend that the change-rooms be cordoned off and all access into this area be prohibited. Since part of the club room is supported off the change-room structure, we also recommend that access into this area be prohibited.

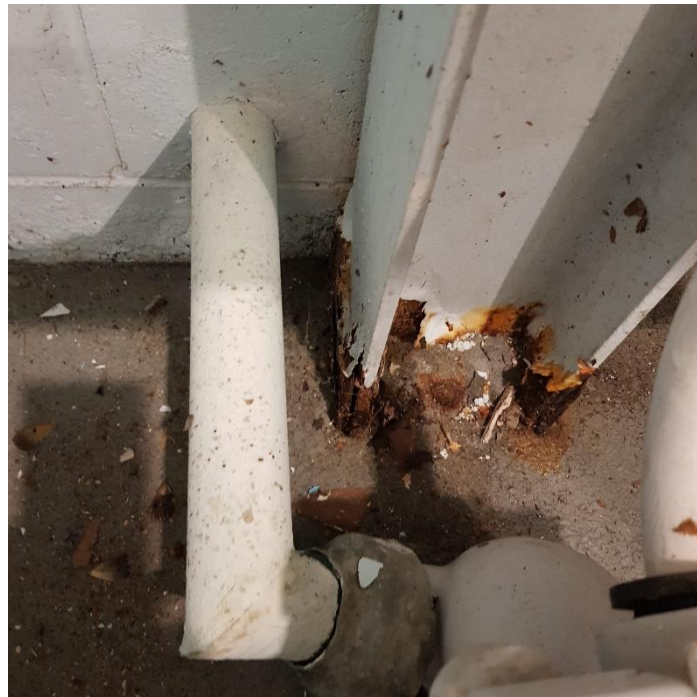
Severe corrosion of steel column base plate

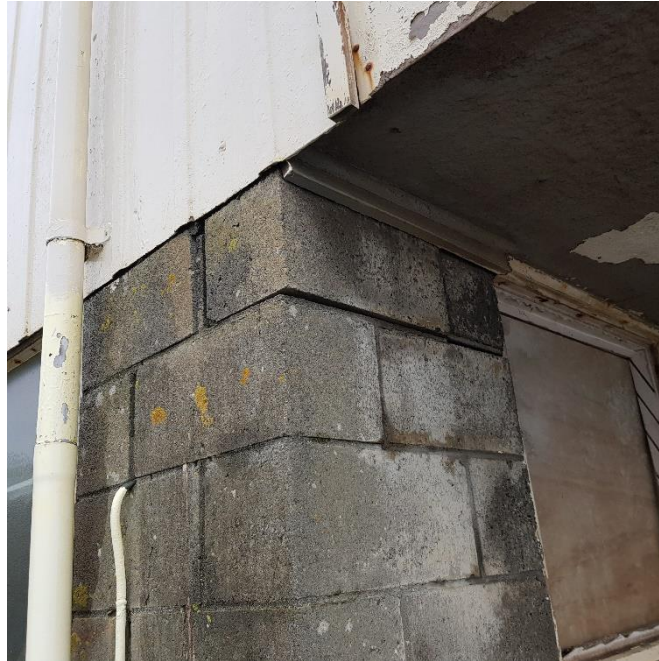
Some blocks at the northwest corner are loose, which may suggest failure of the of the block mortar and blocks. The same was observed at the northeast corner.

Loose blocks in northwest wall corner

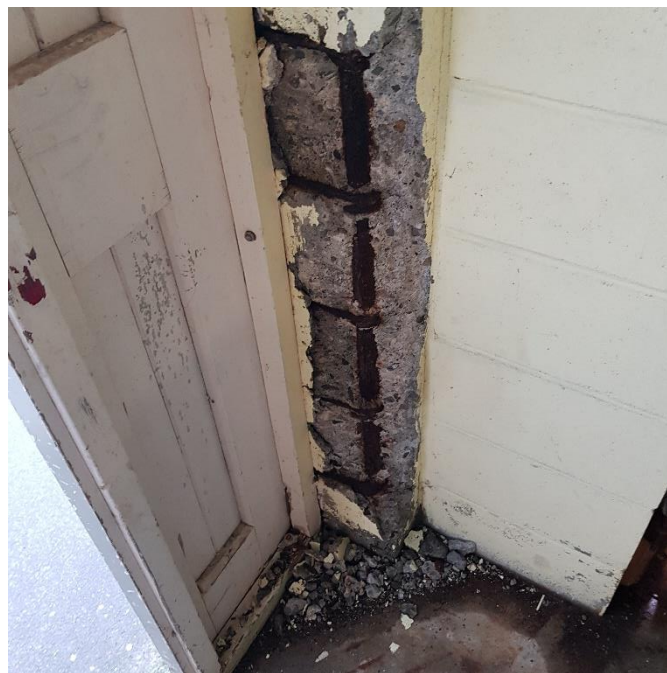
The storage rooms are constructed of reinforced concrete beams and floor and concrete masonry block walls. We understand that this section of the building was constructed by volunteers from the local community. There are numerous areas of the concrete work showing spalling of concrete and corrosion of reinforcement in beams and columns. The main reinforced concrete floor beams are showing visible signs of sagging. The deflection could be because of long spans or may also be because of construction errors.

Concrete column in storage area

We further recommend that the storage areas may continue to be used for the sole purposes of storage only, and access into this area be restricted to selected club personnel only, but with short periods of visits into these rooms.

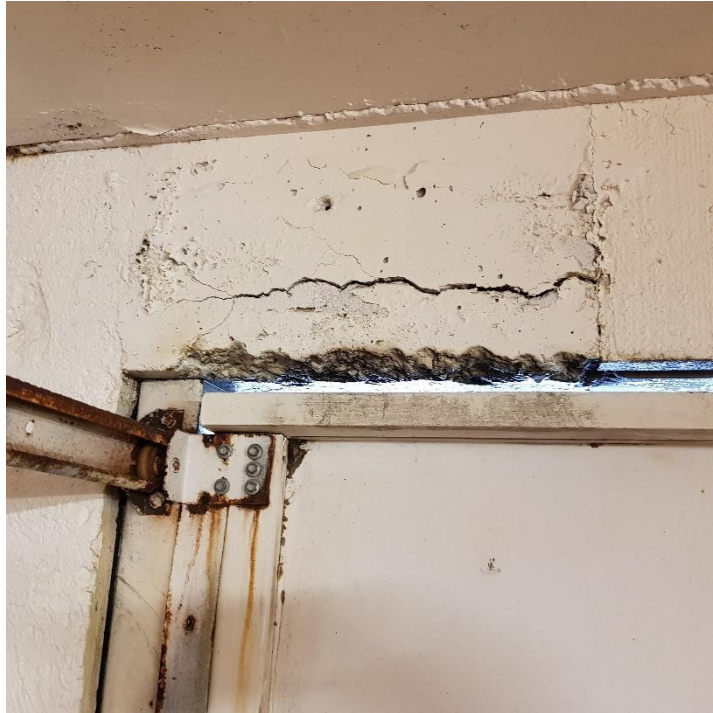
The concrete work in the storage area is showing signs of deterioration. The spalling of the concrete, corrosion of reinforcement and general cracking has compromised the structural performance of these elements, but to a lesser extent compared to the columns in the change rooms.

Cracking in concrete floor beam

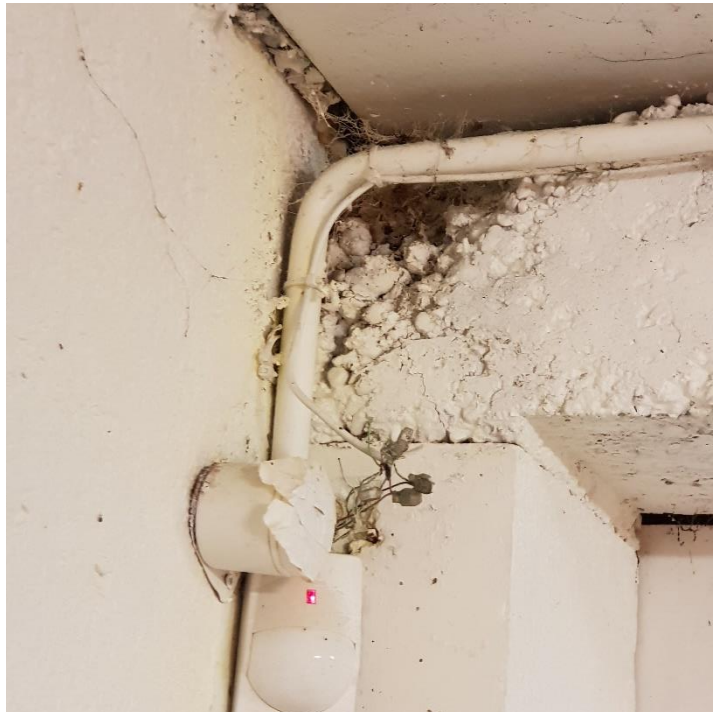
Honeycombing of concrete in critical beam/column joint
